# **GREATER ESSEX COUNTY DISTRICT SCHOOL BOARD**

## **Designated Substance Management Plan**

**DM Eagle PS  
14194 Tecumseh Rd.  
Tecumseh, Ontario  
N8N 1M7**

**Current Version: January 6, 2023**

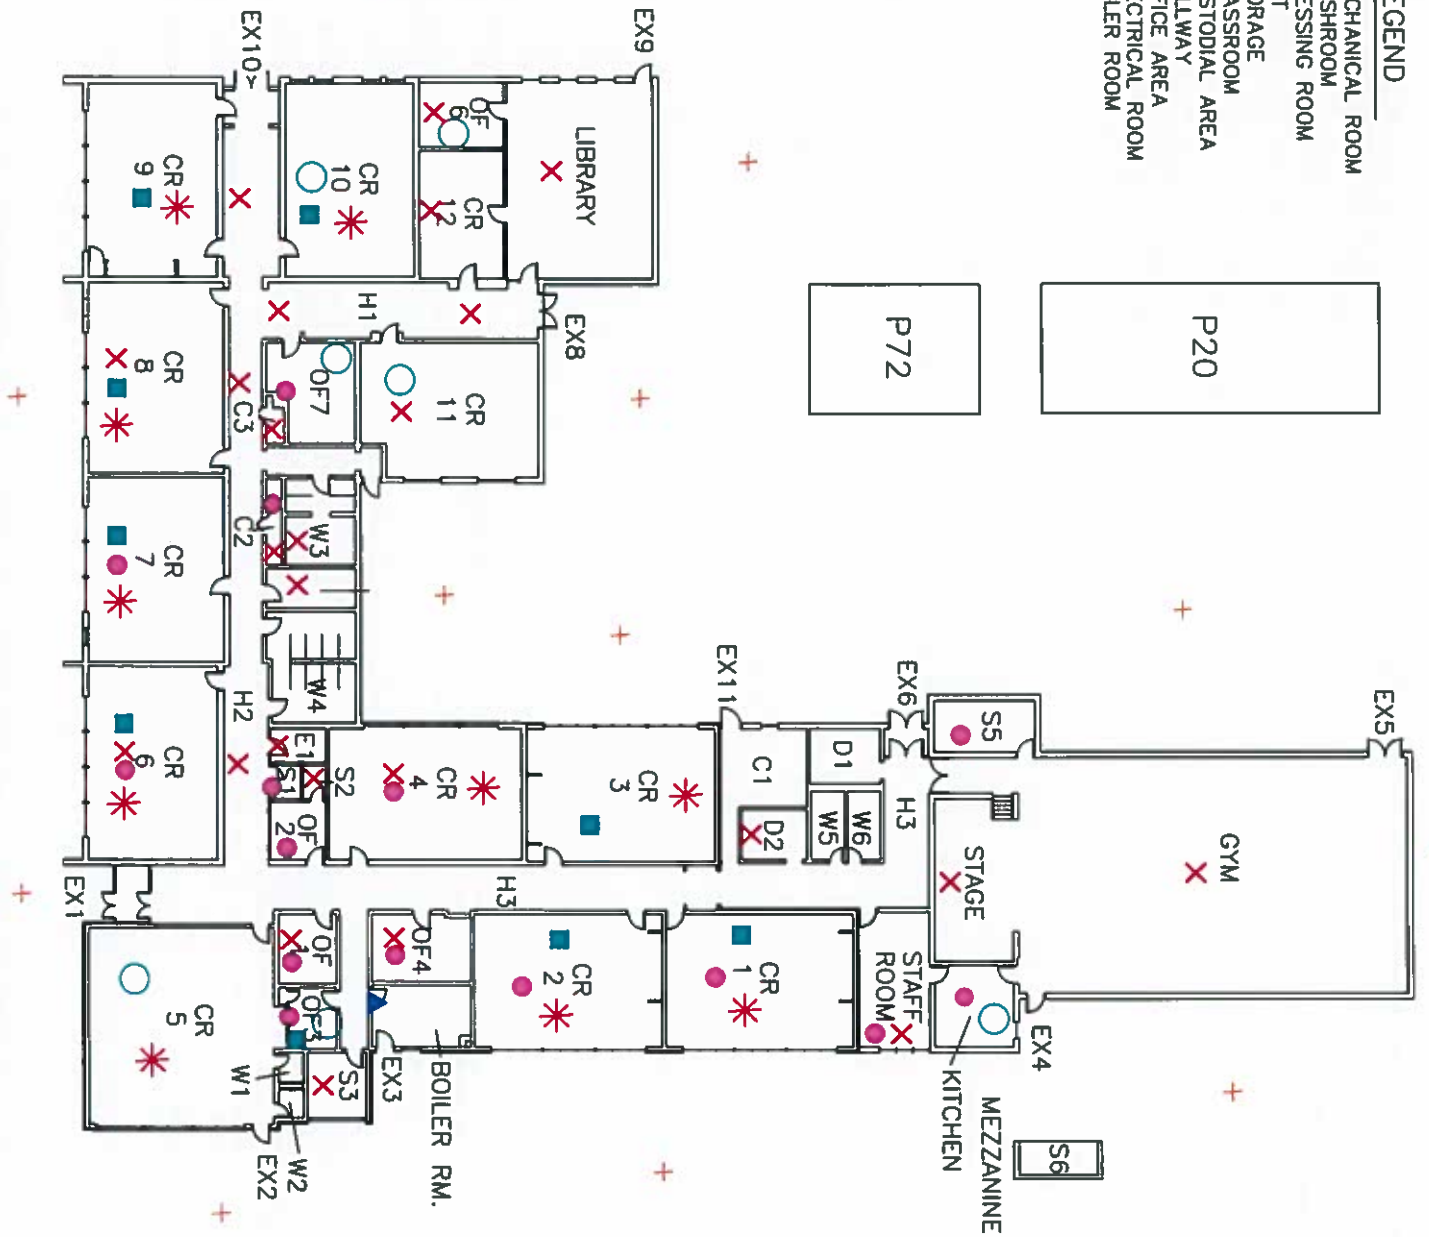
Friable chrysotile asbestos (25–100%) is present in thermal insulation on pipe fittings and straights (i.e. domestic hot and cold water, hot water heating, rain water leaders) in various locations throughout the building. Friable asbestos (assumed) fire door cores are present throughout the building. Non-friable chrysotile asbestos (10%) mastic thermal insulation is present on piping under sinks throughout the building. Non-friable amosite asbestos (5%) acoustical ceiling tiles are present throughout the building. Non-friable asbestos (assumed) gold, white and black mastic anti-sweats are present on the underside of sinks throughout the building. Non-friable asbestos (assumed) interior and exterior caulking materials are present on windows, doors and building penetrations throughout the building. Non-friable asbestos (assumed) chalkboards are present throughout the building. Non-friable asbestos (assumed) vinyl floor tiles measuring 9 inches by 9 inches are present

throughout the building. Non-friable chrysotile asbestos (1-5%) vinyl floor tiles measuring 12 inches by 12 inches are present throughout the building. These friable and non-friable ACMs were found to be in good physical condition (see tables and floor plan for more specifics).
