# **GREATER ESSEX COUNTY DISTRICT SCHOOL BOARD**

## **Designated Substance Management Plan:**

**Kingsville DHS  
170 Main E., Kingsville, Ontario, N9Y 1A6**

**Current Version: March 1, 2025**

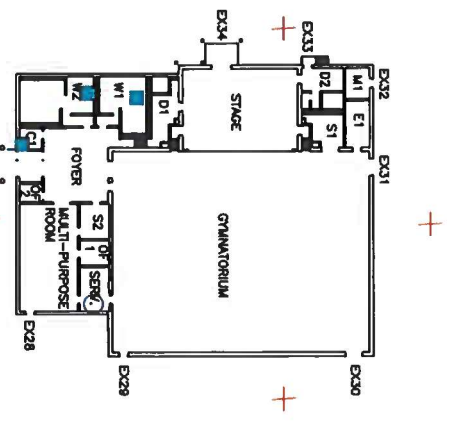
MIGRATION HALL

Friable asbestos (assumed) vermiculite insulation is assumed to be present inside concrete block walls around the perimeter of the building. Non-friable asbestos (assumed) gold anti-sweat mastic is present on the underside of sinks throughout the building. Non-friable asbestos (assumed) interior, exterior caulking and firestop type materials are present on windows and doors as well as building penetrations throughout. Non-friable asbestos (assumed) drywall joint compound is present on drywall finishes in several locations throughout the building. These friable and non-friable ACMs were found to be in good to fair physical condition (refer to tables and floor plans for more information).

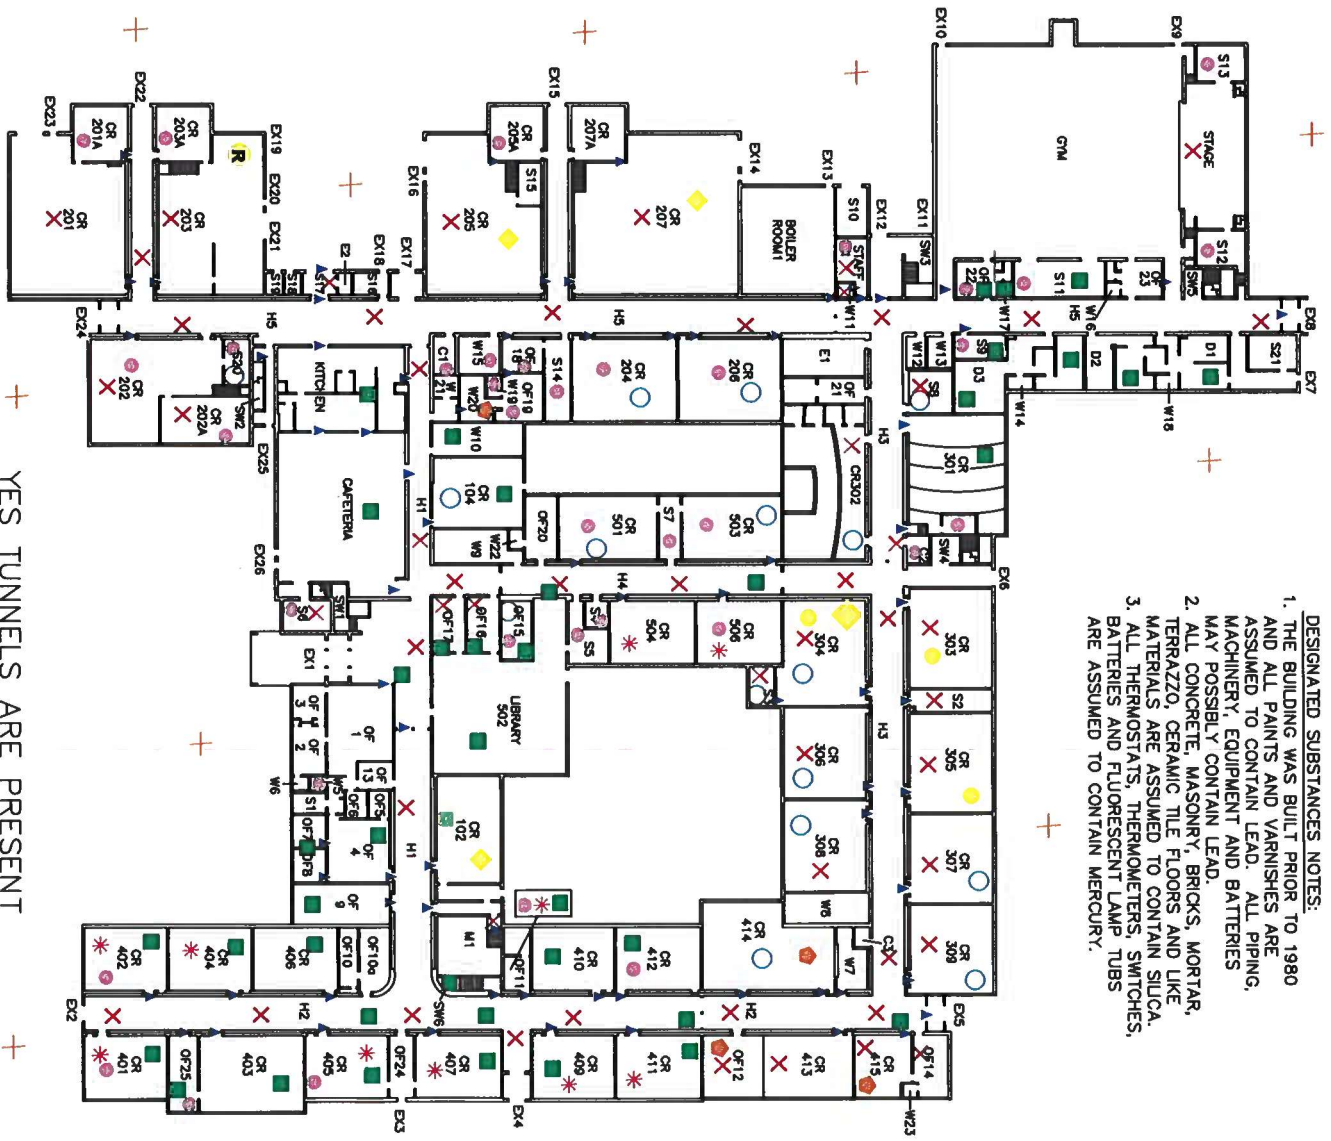
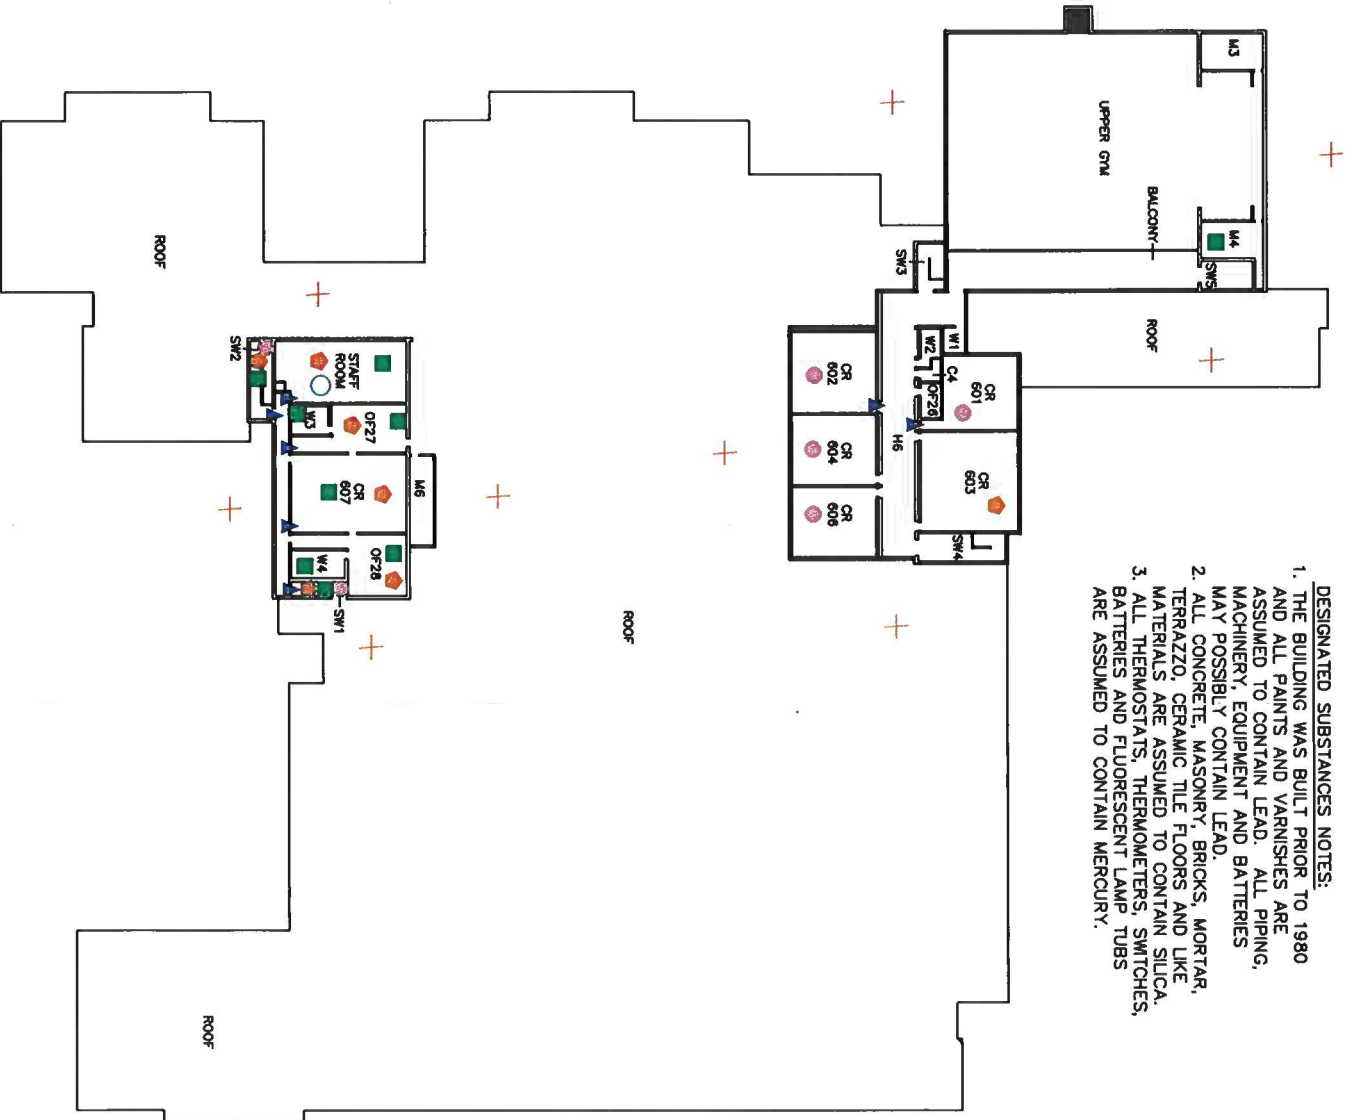
GREATER ESSEX COUNTY  
DISTRICT SCHOOL BOARD  
KINGSVILLE DISTRICT H.S.

YES TUNNELS ARE PRESENT  
YES ASBESTOS IS PRESENT
